BLACKSTONE RIVER BASIN  
MILLBURY, MASSACHUSETTS

DOROTHY POND DAM  
MA 00146

PHASE I INSPECTION REPORT  
NATIONAL DAM INSPECTION PROGRAM

JULY 1978

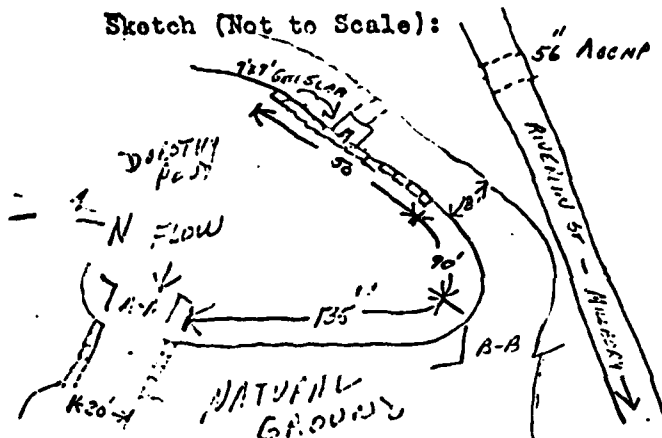
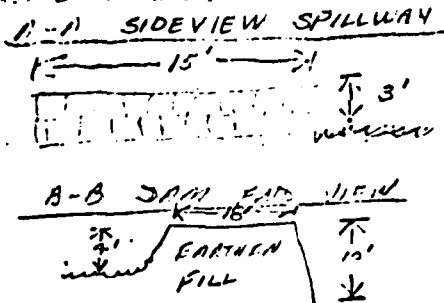
Sketch (Not to Scale):

General Description of Dam and Discharge Control: 24" DRAIN OFF PIPE  
24" AT TOP OF DAM AT GATES, EARTHEN FILL, SPILLWAY  
AT WESTERN END OF DAM, MADE OF STONE, RIVERLIN ST. 5-6 TIMES  
18"-30" ON DAM. SIZE OF GATES NOT SIGN. BARRIER OF ICE.

LARGE OLD TREES SHOULD BE CUT DOWN.
